# GARNESS ENGINEERING GROUP, Ltd.

**Subject:** St. Anthony Apartments Flooding Study

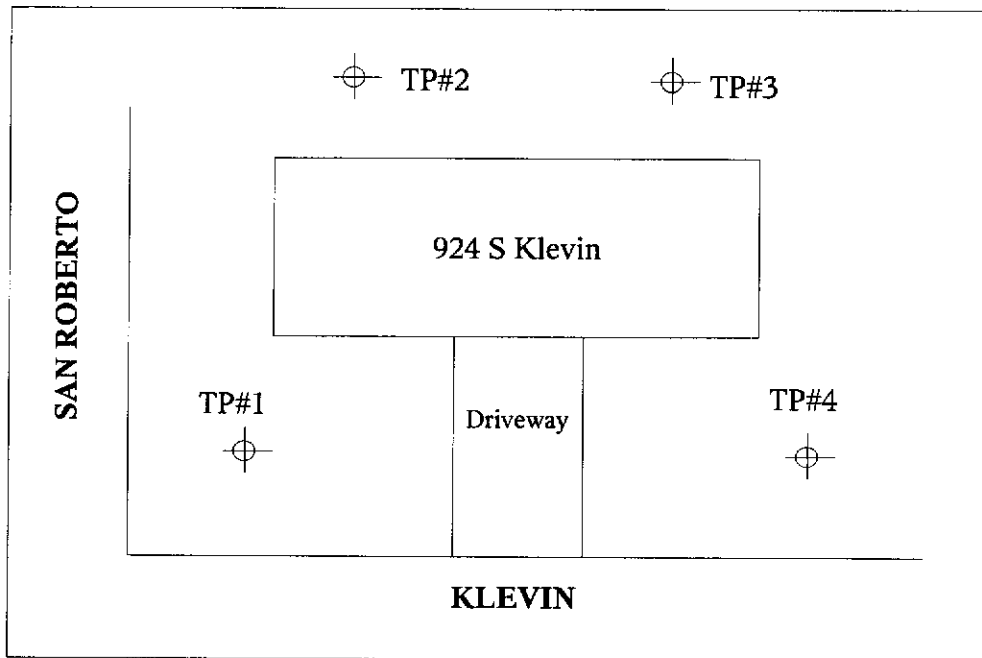
Location of monitoring tubes on property

Please see the attached diagram for test hole locations and the monitoring data. Every test hole revealed similar water levels at or above the elevation of the infiltration problem. Elevated groundwater levels are now verified as the culprit. Water levels did not vary significantly, therefore, an outside source apart from the existing water table is not suspected.

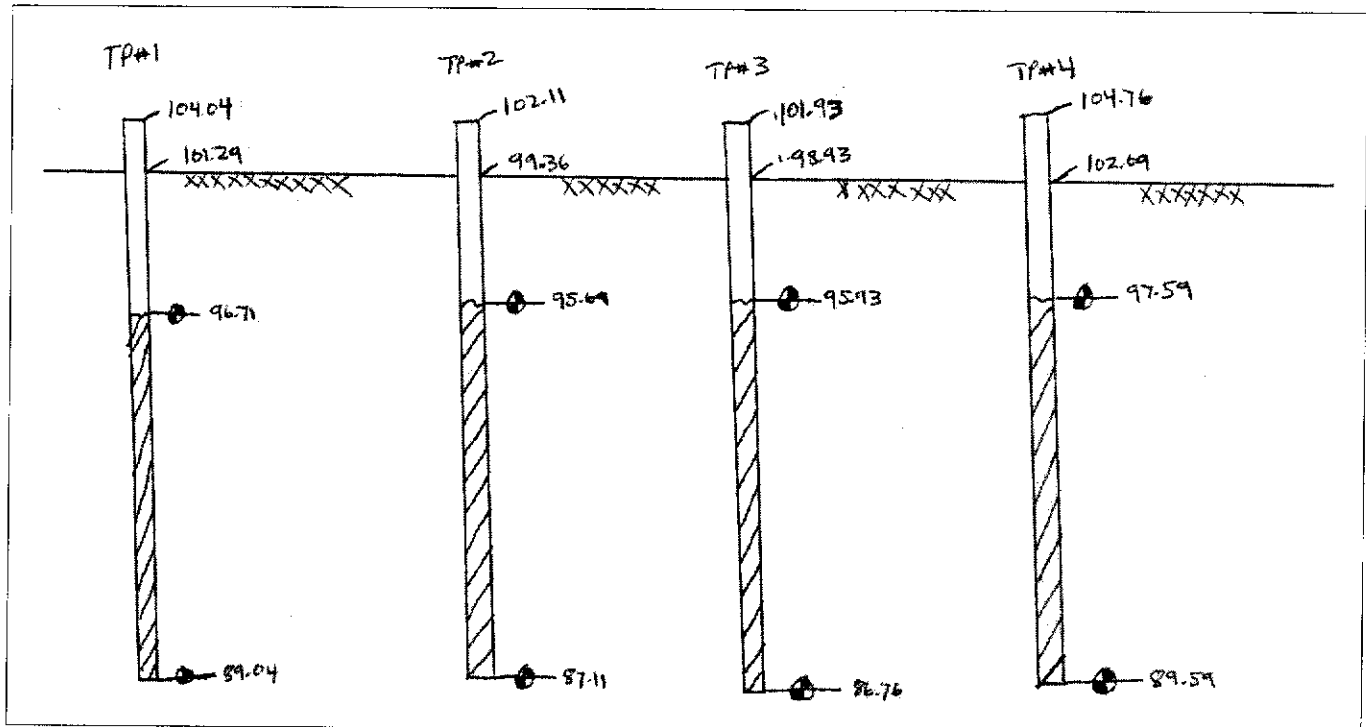
Monitoring Tube Elevation Data from October 11, 2004  
(Top of garage slab = 100.00)

**Water Levels Verified 10-15-04**

- TP#1 96.71
- TP#2 95.69
- TP#3 95.85
- TP#4 97.34

Regrettably, groundwater problems often pose great difficulty in finding reliable, cost-effective solutions. Some possible options include sealing the foundation, installing a foundation drain system, or abandoning the basement and converting it into a crawlspace. Each of these options has serious and costly drawbacks.

Abandoning the basement and converting it into a crawlspace will involve considerable labor and expense. However, this option appears to be preferable to installing a mechanical system to remove collected groundwater.
